Effects of Heating on Teflon® FEP Thermal Control Material From the Hubble Space Telescope

EFFECTS OF HEATING ON TEFLON® FEP THERMAL CONTROL MATERIAL FROM THE HUBBLE SPACE TELESCOPE

9. SPONSORING/MONITORING AGENCY NAME(S) AND ADDRESS(ES)		10. SPONSORING/MONITORING AGENCY REPORT NUMBER	
National Aeronautics and Space Administration Washington, DC 20546-0001		NASA TM—1999-209085

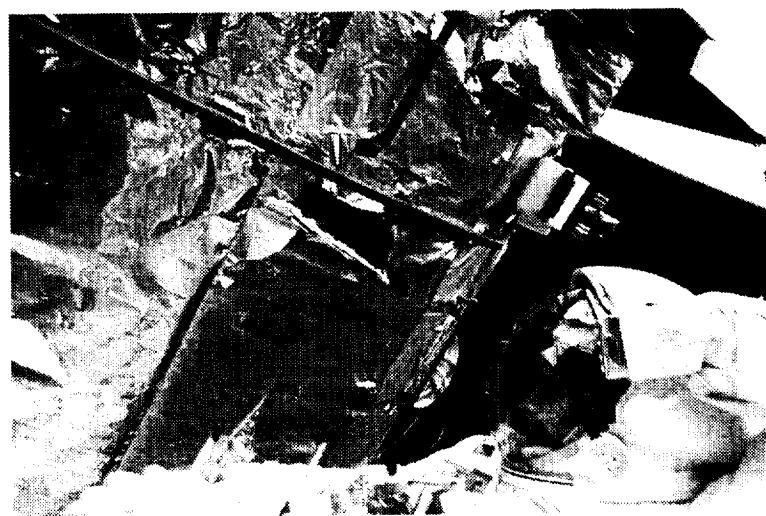
Figure 2. Close-up of the tightly curled Al-FEP MLI section that was cut off and retrieved during SM2 for post-flight analyses.

2.1.3 HST SM2 FEP The SM2 FEP material was from the cracked and tightly curled outer layer of the MLI blanket covering the upper light shield (see Figure 2). The outer layer was composed of 127 μm FEP coated on the backside with 1000 \AA of VDA, and this sample had curled with the FEP surface in compression to a diameter of 1.5 cm.⁵ Two areas of the retrieved SM2 FEP sample were analyzed. One piece was from inside the tightly curled area, which experienced the +200°C temperature extreme when curled. The second piece was from the “flat” section of the retrieved sample, next to the astronaut cut area where the FEP had started to curl. This flat area most likely did not get as hot as the tightly curled area.

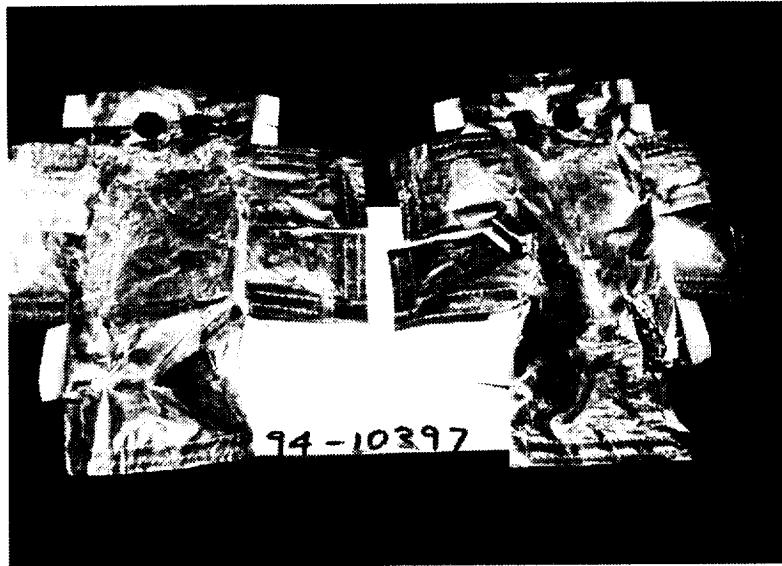
2.1.2 HST SM1 FEP The SM1 FEP material was from the outer layer of one of the two-retrieved magnetometer (or magnetic sensing system (MSS)) electronics box MLI blanket covers. The retrieved MSS MLI blankets are shown in Figure 3. These thermal blankets are roughly 35 cm x 38 cm in size. The outer layer was composed of 127 μm FEP coated on the backside with 1000 \AA of VDA. The MLI blankets were wrapped around the electronics boxes such that each blanket had 5 different areas that experienced difference solar exposures on-orbit.²

Figure 3. Photograph of the two MSS MLI blankets retrieved during SM1.

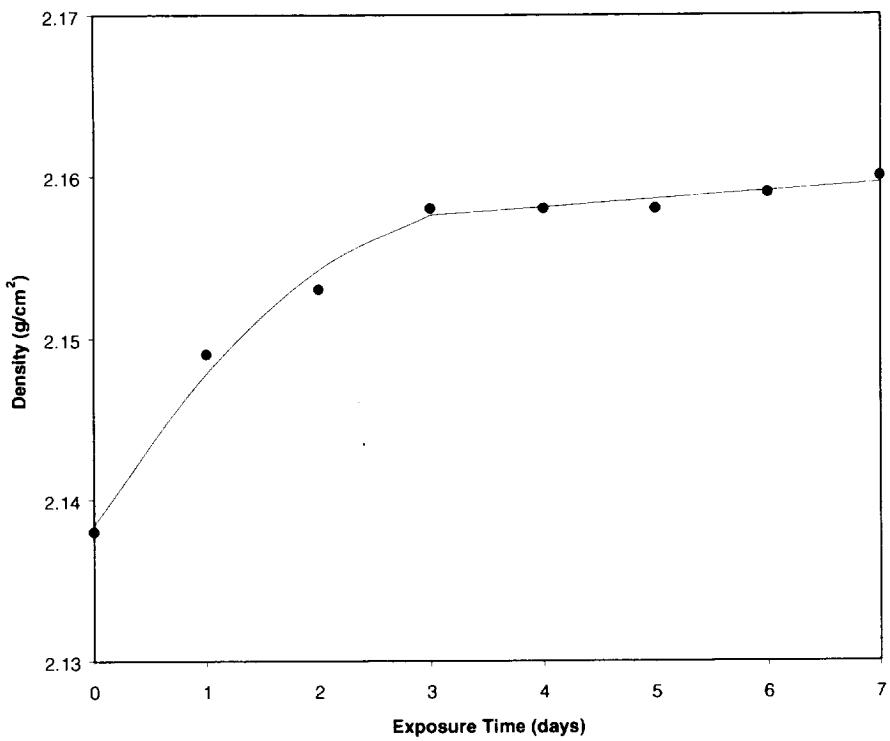
Pristine Al-FEP samples were heated to 200 °C and their densities were found to increase with heating. But, the increase in density of the pristine heated samples was less than for the space exposed samples. For example, pristine FEP increased in density by 0.020 g/cm² after 21 days (0.94%), while the 16,670 ESH SM1 sample increased in density by 0.030 g/cm² after 21 days (1.41%) (Table 4). Samples of pristine FEP were exposed to 200 °C for 1-7 days. These data, shown in Figure 4, indicate that the majority of density increase occurred within 72 hours of heating. An additional sample heated for 21 days showed no additional density increase than experienced after 3 days of heating. Samples of pristine FEP and SM1 FEP (11,339 ESH) were also exposed to temperatures ranging from 50 °C to 200 °C for 21 days to see what temperature causes an increase in density. The results are plotted in Figure 5. There appears to be a very small increase in density with increasing temperature up to 125 °C, then at a temperature of 150 °C and above, the density increases significantly. This was true for both the pristine and the SM1 FEP. The rate at which the density increases was greater for the SM1 FEP than for the pristine FEP, in both regions of the graph. For example, the slope of the SM1 line from 125 °C to 200 °C is 3.34×10^{-4} g/cm² °C, while it is 2.22×10^{-4} g/cm² °C for pristine FEP. These results indicate that heating at temperatures of 150 °C and above, without prior radiation or space exposure, can result in an increased density of FEP. It has been reported that elevated temperature exposure can cause chain scission in polymers.¹³ These results also indicate that prior space exposure causes greater density increases with heating than for unexposed FEP. This supports the idea that space exposure (at nominal temperatures of 50 °C) causes chain scission in the polymer structure, and that with sufficient heating the shorter chains can move into more densely packed areas.

Figure 4. Effect of heating for 1 to 7 days at 200°C on the density of Al-FEP.

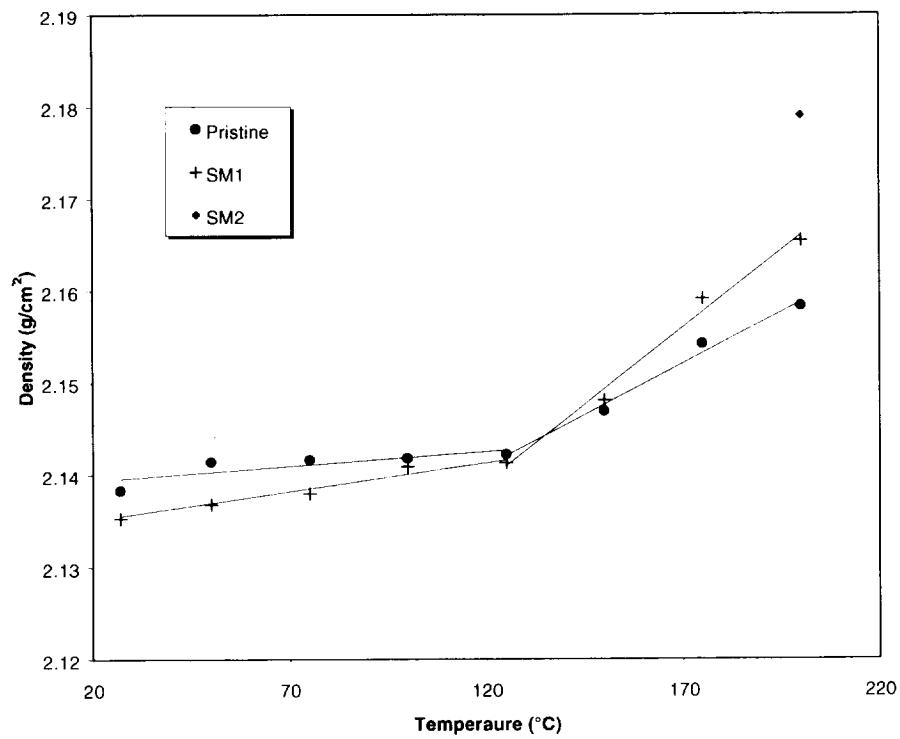
Figure 5. Effect of heating temperature (3 week exposure) on the density of pristine FEP and SM1 FEP.

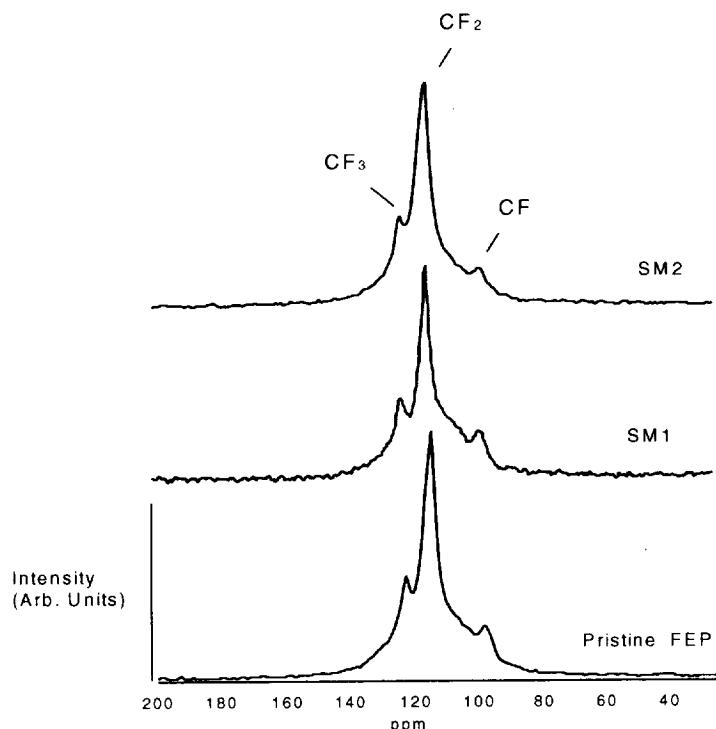
The ^{13}C spectra for all three samples (Pristine FEP, SM1 FEP and SM2 FEP) consist of three peaks at 98, 115, and 122 ppm (frequency shift in ppm from a tetramethylsilane standard) arising from CF , CF_2 , and CF_3 groups, respectively, as shown in Figure 6. A comparison of the SM1 and SM2 FEP with the pristine material shows that there are no new peaks observable in the NMR spectrum after space exposure. These results show that if there is formation of new $-\text{CFX}_-$ species they are present at low levels (<5% of carbon sites). The three spectra also show little change in terms of the relative intensities of the three peaks. These results, in conjunction with the fact that there is little or no additional CFX species, indicate that there is no large-scale chemical modification of the material. The ^{13}C spectra for all three samples did not change after heating at 190°C (there were no indications of new peaks or changes in the relative intensities of the $-\text{CF}_x-$ peaks). Therefore, heating the samples at this temperature did not cause any significant chemical changes to the FEP films, consistent with the as-received SM2 results.

Figure 6. ^{13}C spectra of as-received pristine FEP, SM1 FEP and SM2 FEP.

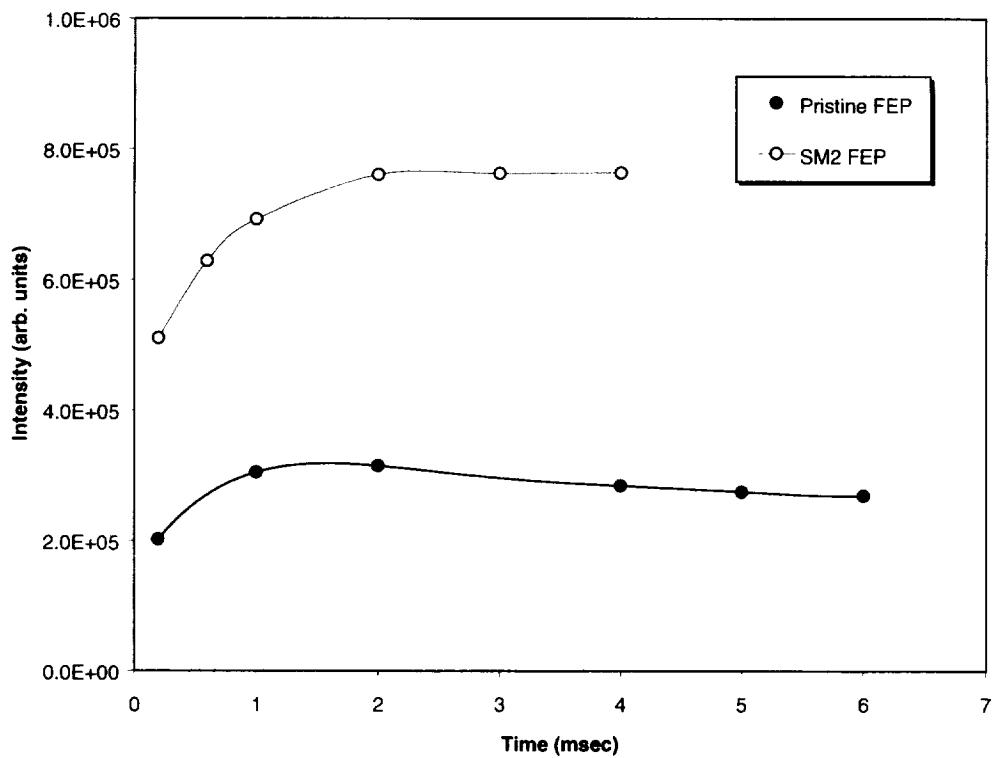
The T_{CF} curve, shown in Figure 7, is a plot of the ^{13}C signal intensity versus the cross polarization time. The rate at which the intensity increases is dependent on the $^{13}\text{C} - ^{19}\text{F}$ dipolar coupling, which in turn is dependent on the molecular motion present. The tighter the chain packing and the less kHz regime motion that is present, the more rapid is the rise in intensity. The T_{CF} curves for the pristine and SM1 samples are nearly identical, indicating that the two samples have a similar structural morphology. However, the T_{CF} curve for the SM2 sample is different from the SM1 sample, the intensity reaches a peak at ≈ 1 ms versus 2 ms. These results indicate that there is less molecular motion and tighter chain packing in the SM2 sample. These changes in morphology may a rise either from material changing from amorphous to crystalline or by the material becoming more ordered within the amorphous domains.

Figure 7. T_{CF} Curves for as-received pristine FEP and SM2 FEP.
